**BS5837 TREE SURVEY REPORT &  
PRELIMINARY CONSTRAINTS ANALYSIS**

**Site Address: The Leach Pottery, Higher Stennack,  
St.Ives, Cornwall, TR26 2HE**

**Ref: Leach5837.3.22**

**Dated: 8<sup>th</sup> March 2022**

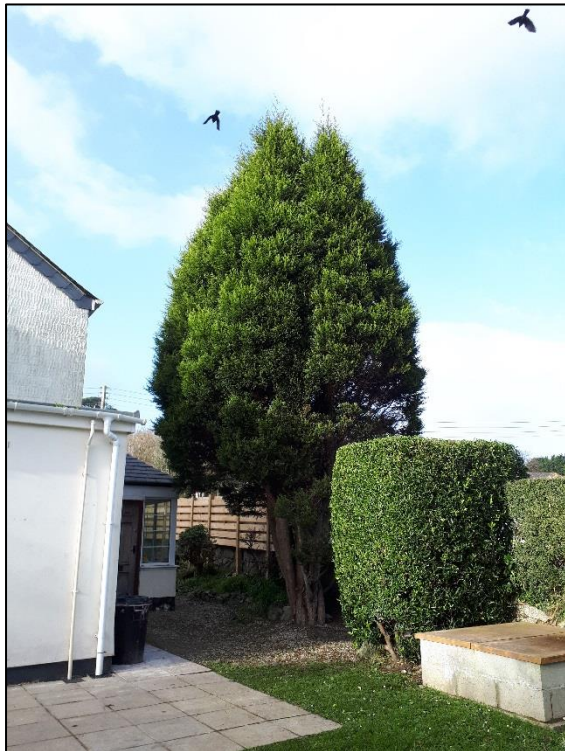
*Fig 1. T1 in existing garden*

- 7.1.1 T1 is located within close proximity to the existing dwelling. The root protection areas should be modified to exclude roots from beneath the structure.

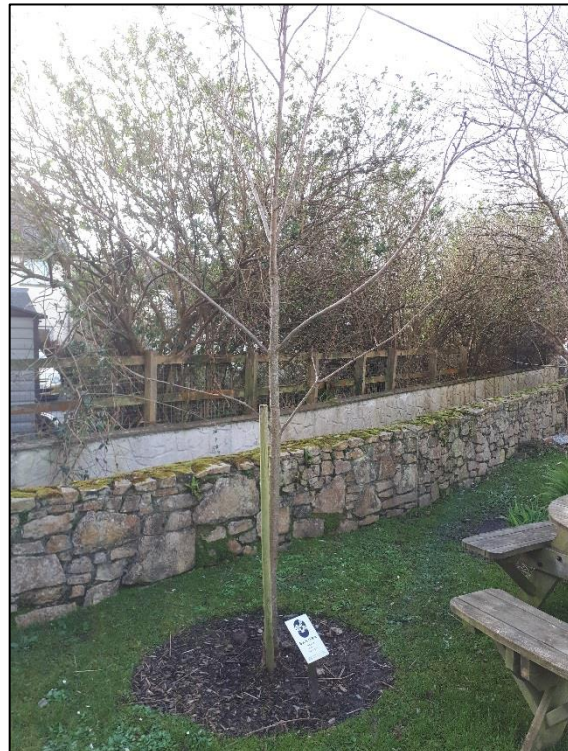
*Fig 2. T2 Sakura Cherry*

9.1.2 T2 & T5 (removed via transplanting)

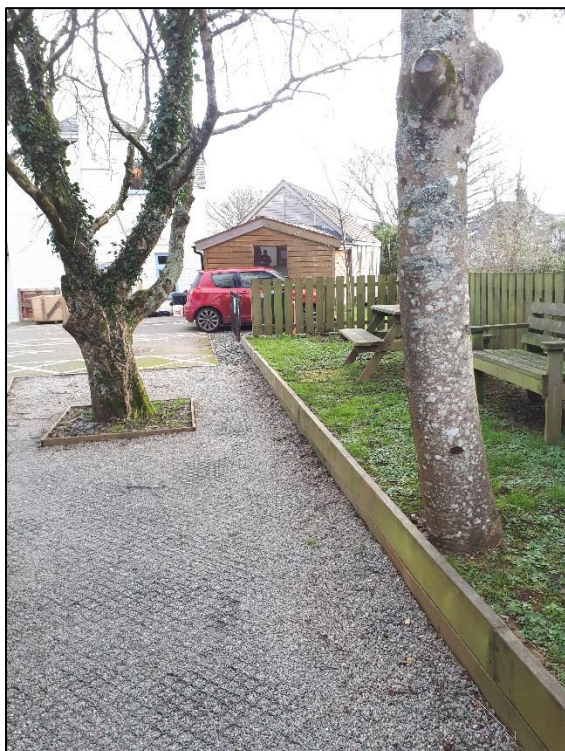
*Fig 3. T3 right & T4 left of image*

- 7.1.3 A geogrid infilled with gravel is present in part of the root protection areas of T3 & T4. The depth of the grid is unclear. Geogrids are not suitable for load displacement. The area is not obviously in use for vehicle parking.

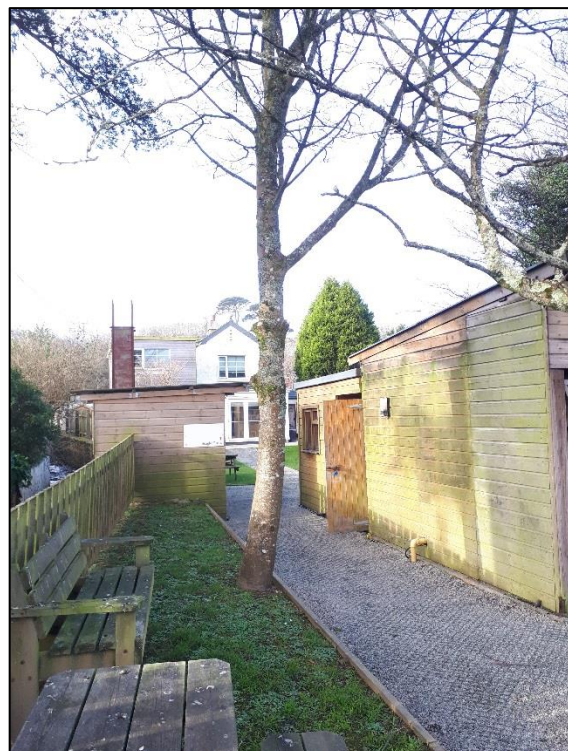
*Fig 4. T3 by existing geogrid pathway*

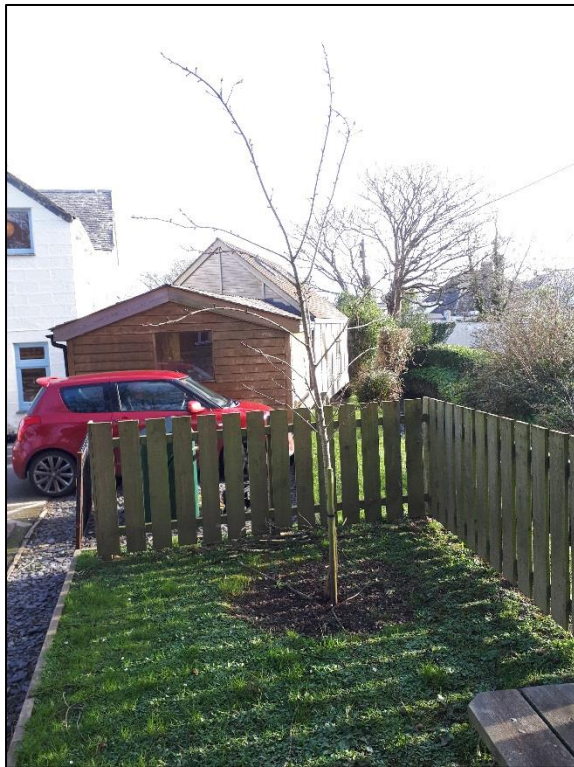
*Fig 5. T5 newly planted Cherry*

- 7.1.4 T2, T5 & T10 are newly planted or recently established cherry trees which have been donated to the Leach Pottery. The trees should be regarded as being important and efforts made to successfully transplant the trees elsewhere on site.

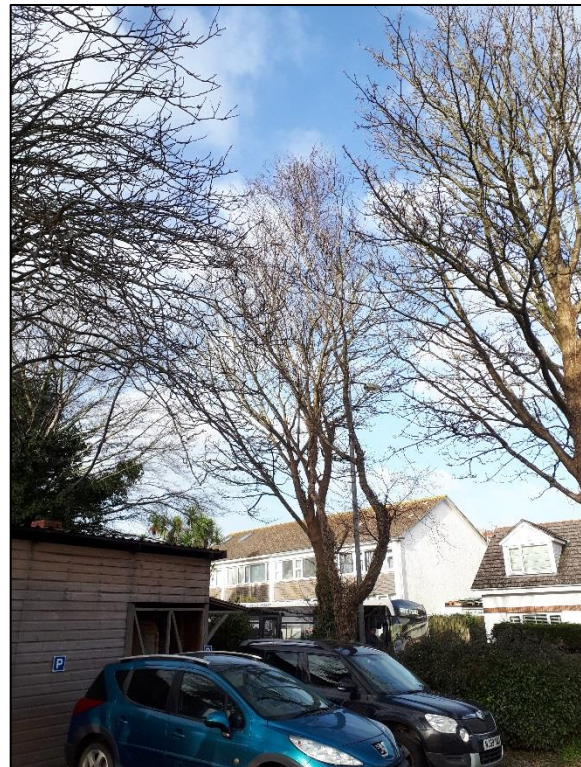
*Fig 6. G1 with light suppressed form*

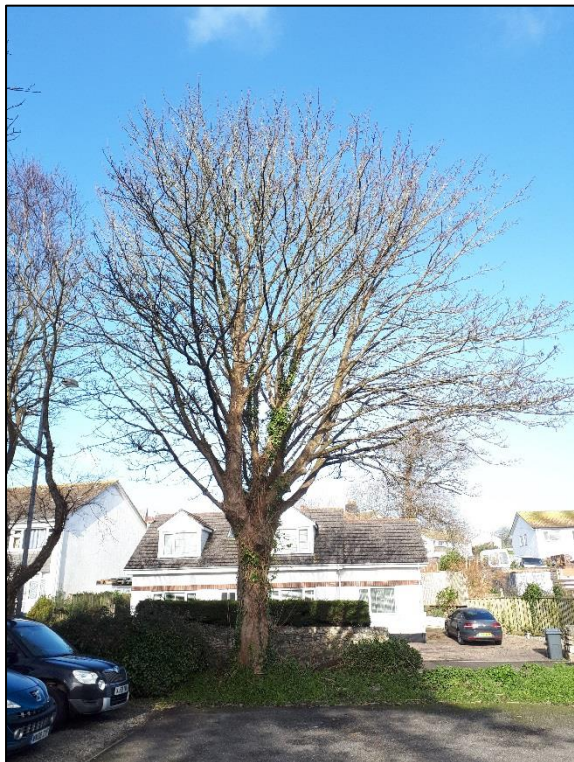
*Fig 7. T7 on boundary hedge*

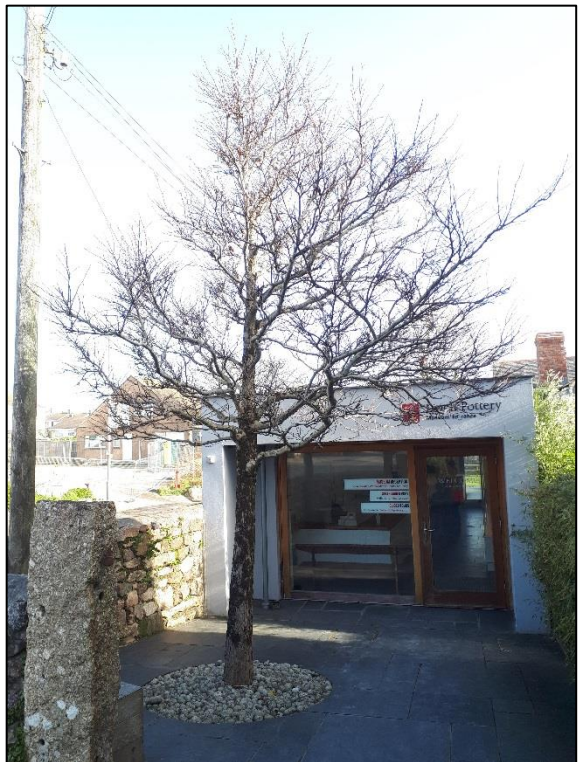
*Fig 8. T8 by existing pottery entrance*

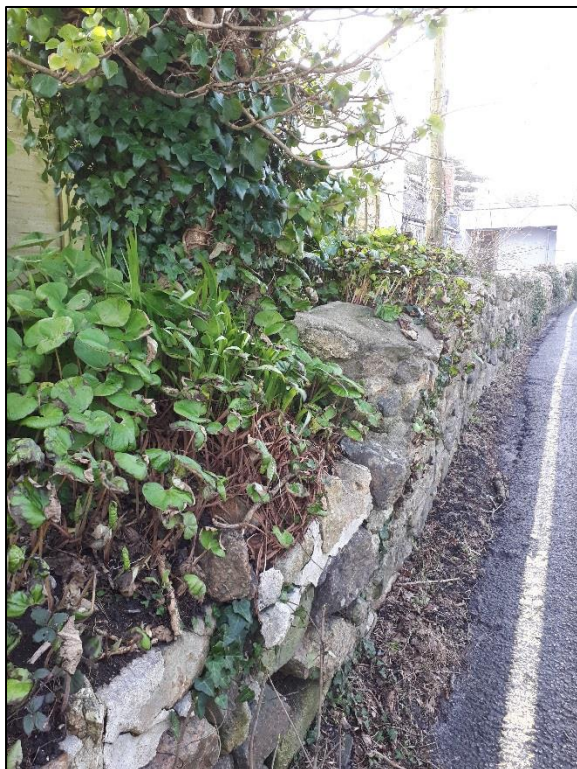
*Fig 9. T9 direct damage to boundary wall*

- 7.1.5 T9 does not exhibit any obvious symptoms of Ash Dieback (*Hymenoscyphus fraxineus*), but I accept that the identification of symptoms in the winter months is difficult in the early stages of infection. T9 is causing direct damage (root expansion) to the boundary wall below the stem base. Stones have been displaced from this structure.

9.2.1 T8, T9, G2

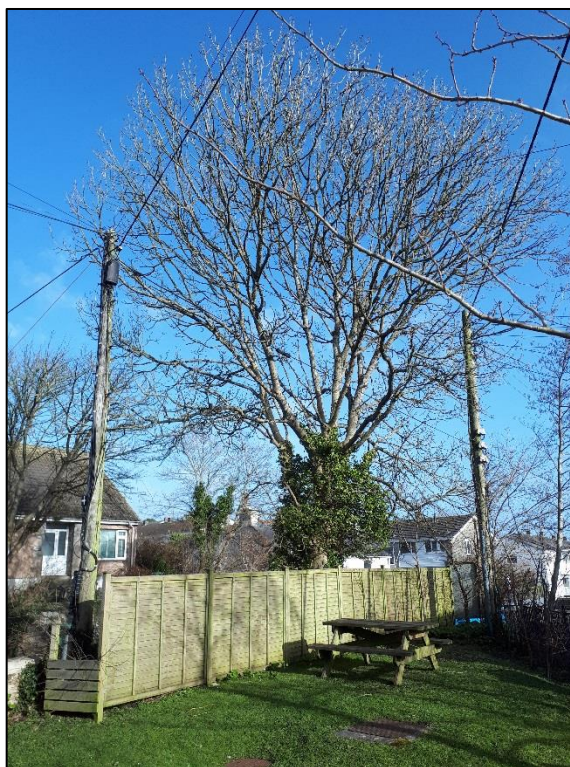
*Fig 10. T9 on site boundary*

- 7.2.7 T9 is prominently positioned within the street scene and makes a locally notable contribution to The Stennack on the approach from the north. The future contribution is questionable, pending further monitoring for Ash Dieback. Currently, T9 makes a positive contribution to the local area.

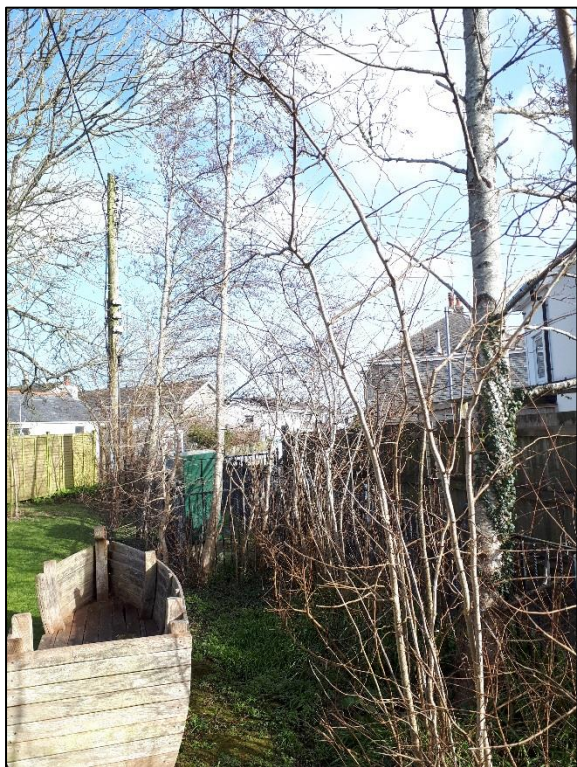
*Fig 11. G4 by drainage infrastructure*

- 7.2.8 Trees within G4 make a modest contribution to the local area. The common alder are likely to make a limited future contribution due to their proximity to an engineered drainage feature.

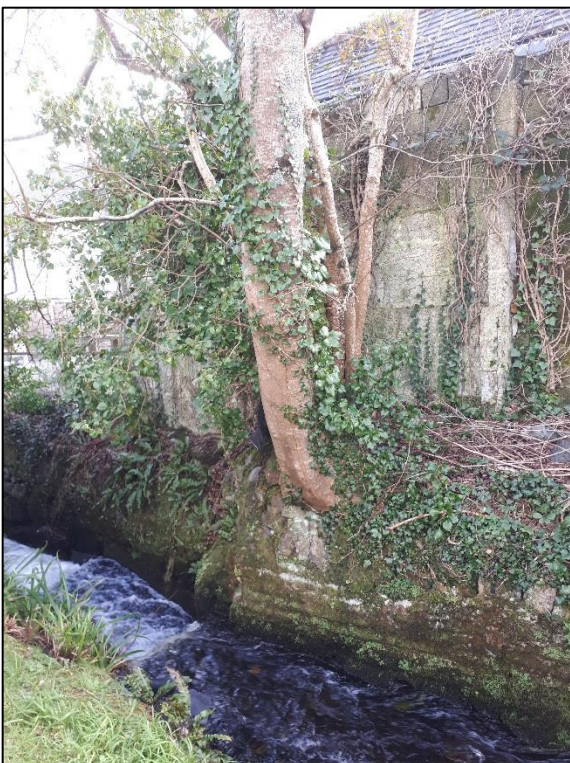
*Fig 12. OST1 by watercourse*

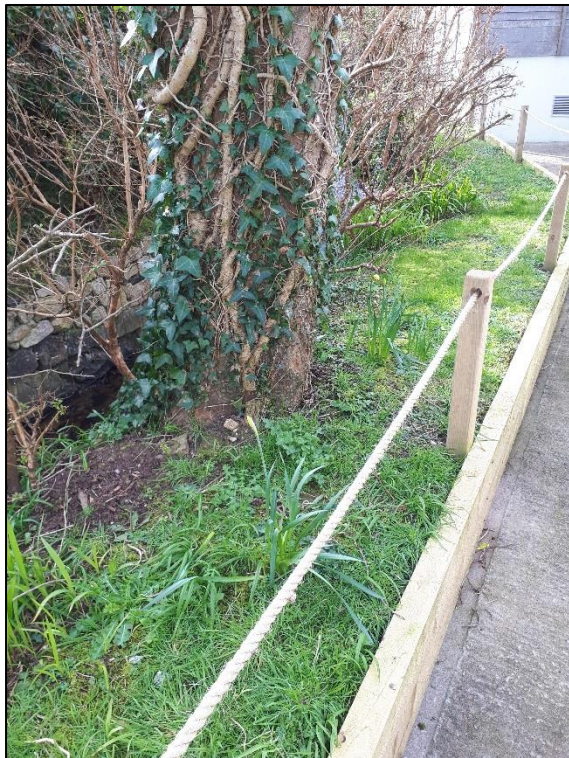
*Fig 13. T12 on pottery side of watercourse*

- 7.1.7 T12 is growing on the bank to the north-west of the watercourse channel. The root protection area should be modified to exclude it from the permanently waterlogged channel, but it cannot be modified due to the presence of the existing building.

- 7.1.8 The root protection area of T12 is covered in part by an existing concrete pathway which provides a stable means of pedestrian access to the eastern side of the building.

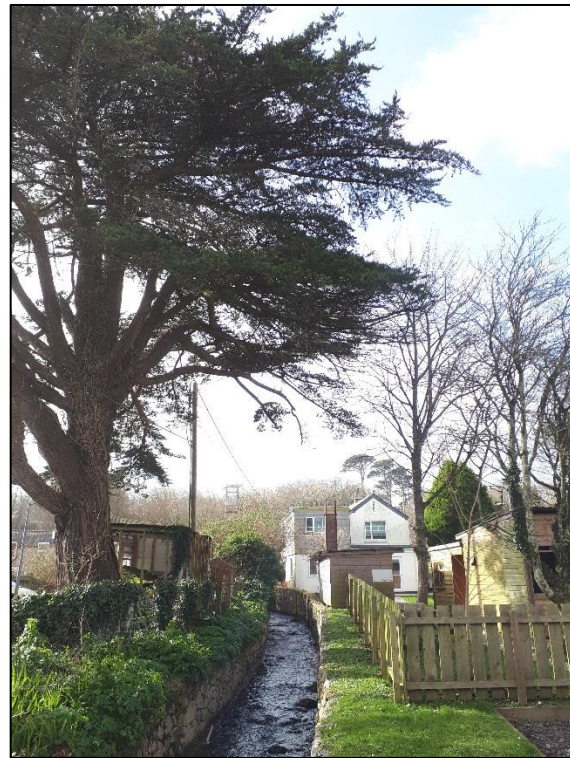
3.4.2 A Tree Preservation Order is applicable to tree OST4 which is located in third-party ownership to the south-east of the project area.

*Fig 14. OST4 relationship to pottery*

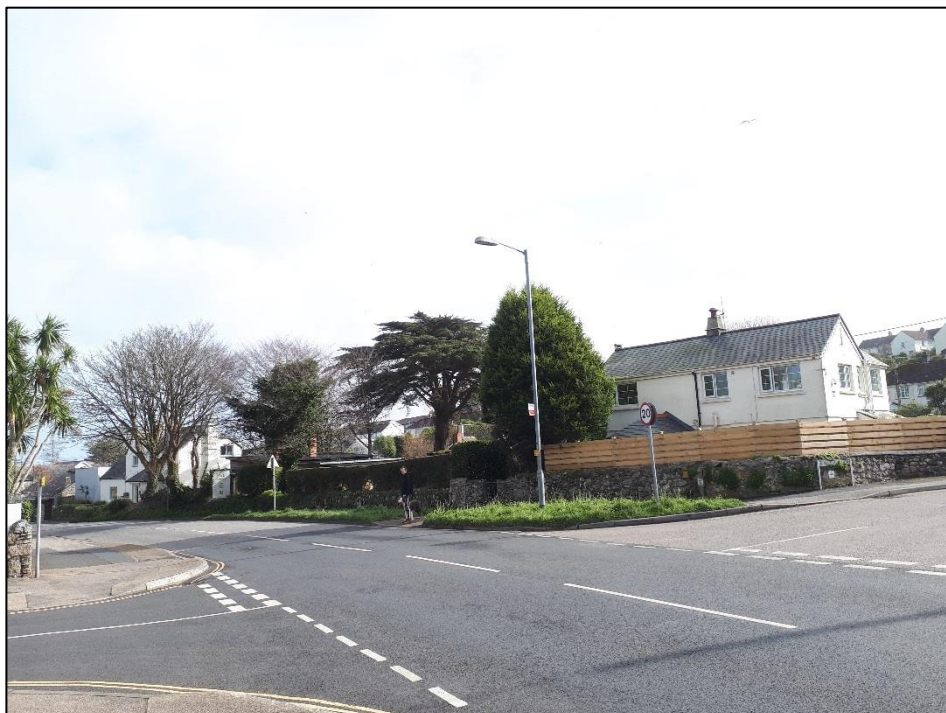
*Fig 15. Survey area viewed from south-west (T1)*
