S10 Geo-Consulting

Geotechnical & Geo-environmental Ground Investigation

Leach Pottery
Higher Stennack
St Ives
Cornwall
TR26 2HE

22-137

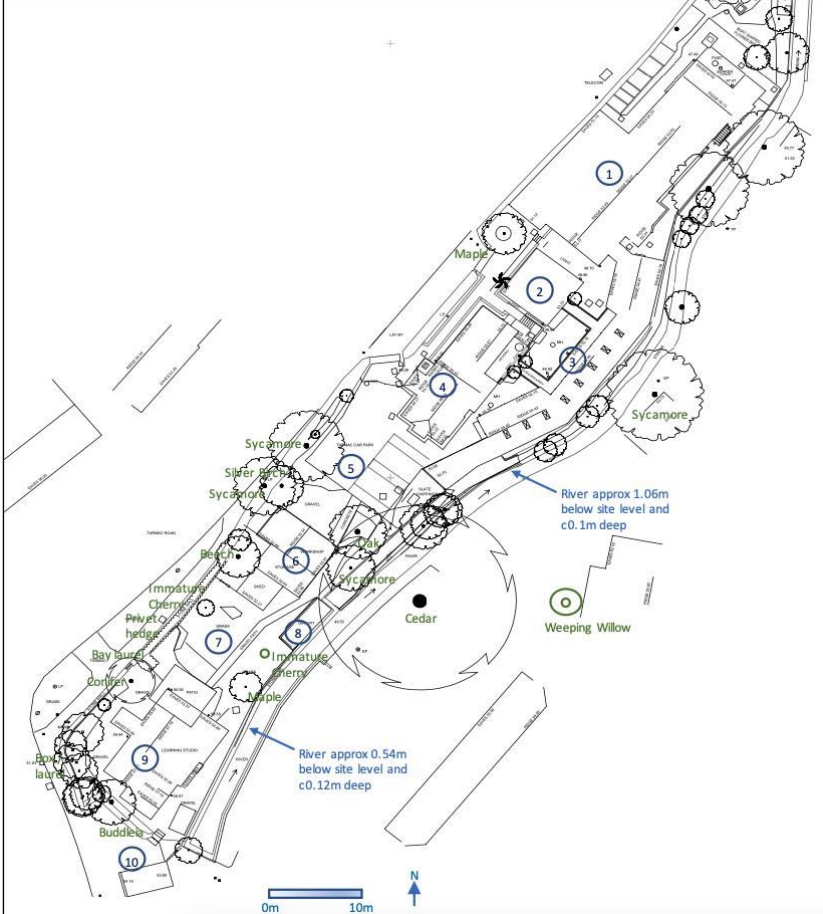
<p>FIG 1.2b: EXISTING SITE LAYOUT – based upon Dow Jones Architects Drg No. 488-01-050, dated Feb 22; Scale: as shown</p>
	<p>The Site comprises Leach Pottery, a 100 year old pottery including clay room, throwing room, workshops, kilns, museum, galleries and shop. Access can be gained mid-way along the northwest boundary from Higher Stennack (road), itself forming the NW site boundary, whilst the Stennack River forms the SE & NE boundaries. Penbeagle Lane forms the SW site boundary. A site reconnaissance was carried out on 15th September 2022 which identified the following pertinent buildings/features.</p> <ol style="list-style-type: none"> 1. Original pottery building (1920s) including later museum addition. Two-storey part-rendered stone construction with slate roof tiles and plastic rainwater goods. 2. Single-storey Cube gallery (2008) adjacent to museum entrance. 3. Workshop space with raised wooden walkway connecting to gallery and shop. Single-storey timber frame, cladding & roof construction incl. galvanised rainwater goods around central gravel-surfaced courtyard. 4. Shop & gallery (1920s building). Two-storey rendered stone building with slate roof tiles and plastic rainwater goods. 1st floor of building dedicated to office space. 5. Part tarmac, part gravel-surfaced car park. 6. Single-storey wooden-framed & clad pottery workshop incl. gas-fired kilns. 7. Outdoor grass-surfaced garden incl. picnic benches. 8. Covered area incl. pottery-clay storage and external gas-fired kilns. 9. Learning studio/classroom. Two-storey rendered stone construction with slate roof tiles and plastic rainwater goods. 10. Single-storey, flat-roof (felt) garage of presumed brick / blockwork construction. Unable to access. <p>A number of photographs are presented in Appendix 1, along with a plan showing their positions and orientations. It is worthy of note at this point that there was no obvious visual and/or malodourous evidence of contamination within or surrounding the Site.</p>

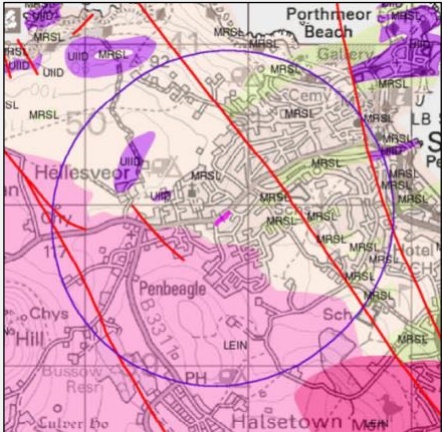
<p>Mylor Slate Formation – (MRSL) generally comprising dark grey, locally green-grey slates, interbedded with thin bands and laminae of sandstone, siltstone, basic lavas and sedimentary breccias (the latter are particularly significant in the upper 500m of the formation).</p> <p>Numerous geological faults mapped in the area, though none through the site.</p> <p>The site lies in an area dominated by historic tin and copper ore mining, specifically tin ore mining as part of the St Ives Consols mine, although no actual shafts are recorded on-site or within influencing distance of the site boundary; depth to worked ore seams >100m below ground level</p>	<table border="1" data-bbox="874 763 1428 1025"> <thead> <tr> <th>Map Colour</th> <th>Lex Code</th> <th>Rock Name</th> <th>Rock Type</th> <th>Min and Max Age</th> </tr> </thead> <tbody> <tr> <td> </td> <td>LEIN</td> <td>Land's End Intrusion</td> <td>Granite</td> <td>Not Supplied - Carboniferous</td> </tr> <tr> <td> </td> <td>LEIN</td> <td>Land's End Intrusion</td> <td>Microgranite, Aplitic</td> <td>Not Supplied - Carboniferous</td> </tr> <tr> <td> </td> <td>MRSL</td> <td>Mylor Slate Formation</td> <td>Metabasalt</td> <td>Not Supplied - Frasnian</td> </tr> <tr> <td> </td> <td>MRSL</td> <td>Mylor Slate Formation</td> <td>Hornfelsed Slate and Hornfelsed Siltstone</td> <td>Not Supplied - Frasnian</td> </tr> <tr> <td> </td> <td>UID</td> <td>Unnamed Igneous Intrusion, Devonian</td> <td>Metagabbro and Metamicrogabbro</td> <td>Not Supplied - Devonian</td> </tr> <tr> <td> </td> <td></td> <td>Faults</td> <td></td> <td></td> </tr> </tbody> </table> <p>Any clay/silt beds in the highly weathered mantle of the MRSL may be shrinkable and could therefore influence founding depth in the proximity of surrounding trees</p> <p>Historic mining-related risk – refer to Wheal Jane Consultancy Desktop Mining Search (Appendix 7)</p>	Map Colour	Lex Code	Rock Name	Rock Type	Min and Max Age	 	LEIN	Land's End Intrusion	Granite	Not Supplied - Carboniferous	 	LEIN	Land's End Intrusion	Microgranite, Aplitic	Not Supplied - Carboniferous	 	MRSL	Mylor Slate Formation	Metabasalt	Not Supplied - Frasnian	 	MRSL	Mylor Slate Formation	Hornfelsed Slate and Hornfelsed Siltstone	Not Supplied - Frasnian	 	UID	Unnamed Igneous Intrusion, Devonian	Metagabbro and Metamicrogabbro	Not Supplied - Devonian	 		Faults

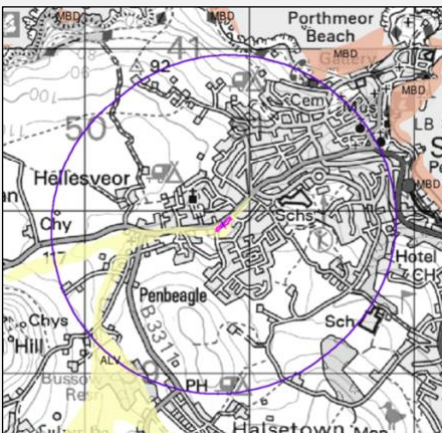
<p>Alluvium mapped coincident with the Stennack River course, likely to underlie the site</p>	<table border="1" data-bbox="874 1585 1428 1731"> <thead> <tr> <th>Map Colour</th> <th>Lex Code</th> <th>Rock Name</th> <th>Rock Type</th> <th>Min and Max Age</th> </tr> </thead> <tbody> <tr> <td> </td> <td>ALV</td> <td>Alluvium</td> <td>Clay, Silt, Sand and Gravel</td> <td>Not Supplied - Holocene</td> </tr> <tr> <td> </td> <td>MBD</td> <td>Marine Beach Deposits</td> <td>Sand and Gravel</td> <td>Not Supplied - Quaternary</td> </tr> <tr> <td> </td> <td>HEAD</td> <td>Head</td> <td>Clay, Silt, Sand and Gravel</td> <td>Not Supplied - Quaternary</td> </tr> </tbody> </table> <p>Alluvial clays/silts have the potential to be soft and shrinkable</p>	Map Colour	Lex Code	Rock Name	Rock Type	Min and Max Age	 	ALV	Alluvium	Clay, Silt, Sand and Gravel	Not Supplied - Holocene	 	MBD	Marine Beach Deposits	Sand and Gravel	Not Supplied - Quaternary	 	HEAD	Head	Clay, Silt, Sand and Gravel	Not Supplied - Quaternary

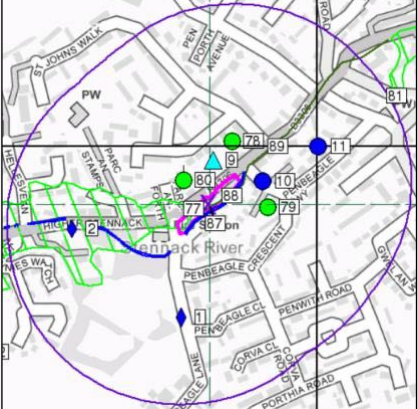
<p>Large swathe of ground extending to the west of the site recorded as potentially infilled land (green-hatched; unknown filled ground – associated with historic mining legacy) Historic mineshafts (green circles) also shown as potentially infilled land Culverted section of the Stennack River extending to the northeast of the site recorded as potentially infilled land</p>

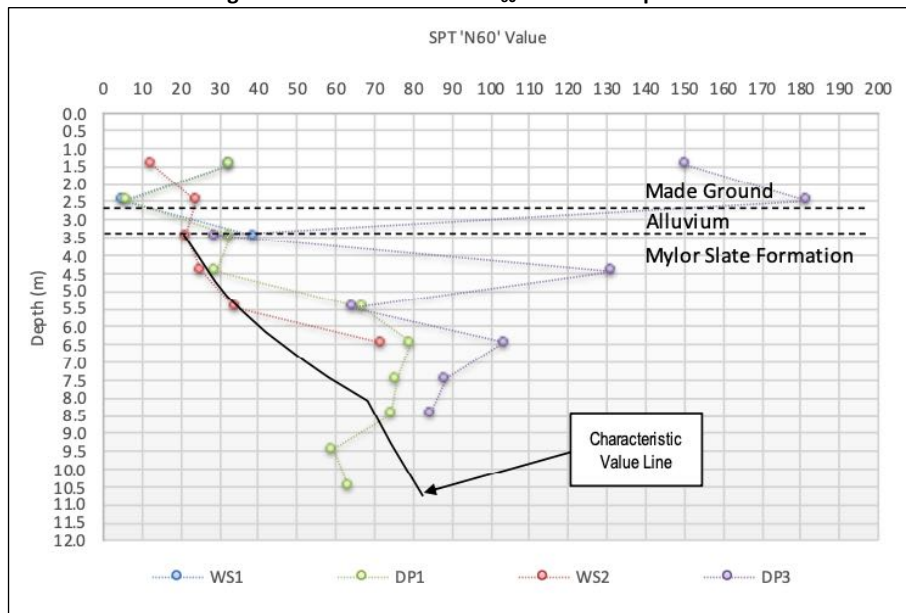
Fig 3.3.1: 'Normalised' SPT N₆₀ Value -v- Depth

As previously noted, Standard Penetration Tests (SPT) were undertaken in accordance with BS EN ISO 22476-3:2005 to assess the relative density of the material penetrated; unfactored N-values are presented upon the respective borehole logs in Appendix 2, with 'normalised/factored' results plotted against depth in Fig 3.3.1 below along with dynamic probe results (converted into equivalent SPT N-values).

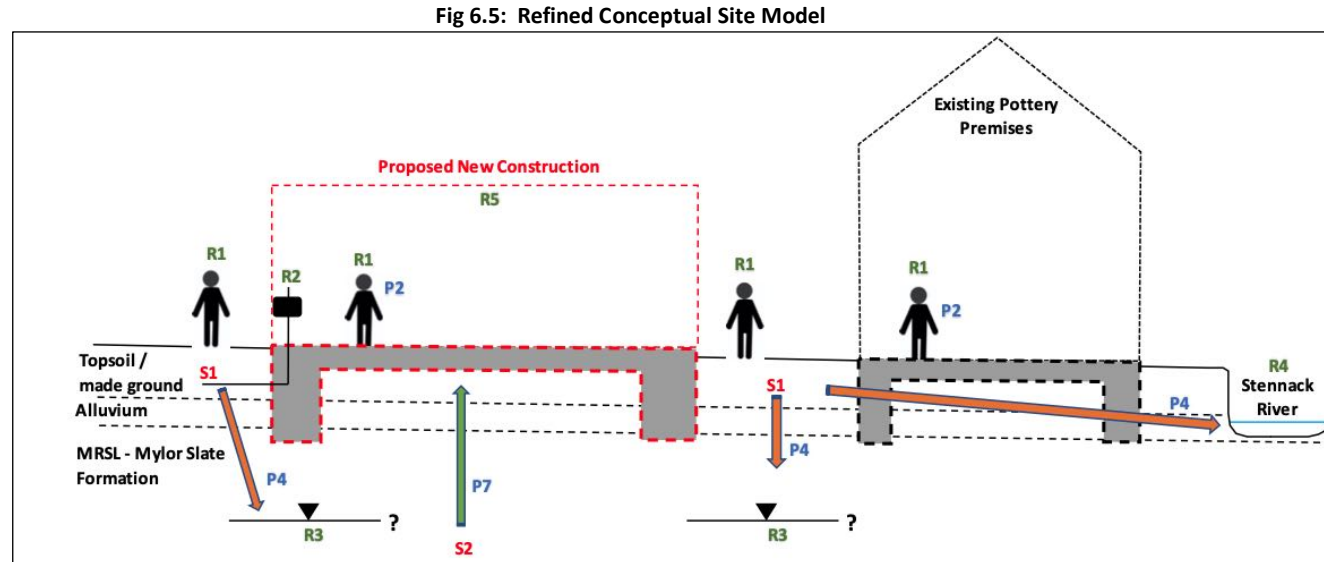
In view of the above discussions the Preliminary Conceptual Site Model has been refined as shown in Figure 6.5 below.

Potential Sources	Pathways	Receptors						Comments	Refined Risk Rating	Remedial / Mitigation Requirements
		R1	R2	R3	R4	R5	R6			
ON SITE										
S1	P1							Whilst laboratory testing has shown that there could theoretically be a perceived risk to controlled waters (secondary A aquifer and adjacent Stennack River), given the existing / proposed predominance of impermeable hardstand and that the offending made ground beneath the site will differ little to that beneath the wider region outside the site, pre-construction remedial measures in respect of controlled waters are considered unnecessary. However, the siting of soakaways in such material should be avoided in order to mitigate risk of unacceptable leachate generation and impaction of groundwater / nearby surface waters	Low - Moderate	The siting of soakaways in made ground material should be avoided in order to mitigate risk of unacceptable leachate generation and impaction of groundwater / nearby surface waters

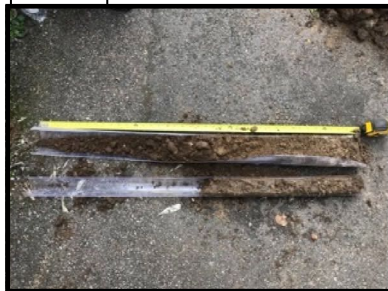
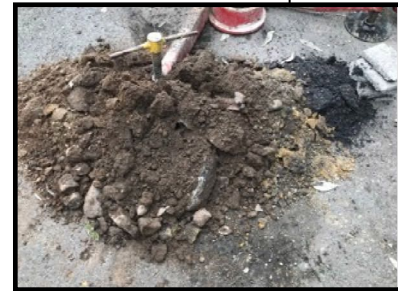
4.0m						Borehole terminated at 3.45m depth due to bending drill rods and collapse of loose cobbles near surface; dynamic probe carried out adjacent to borehole

Casing used: No
 Trees: Refer to site drawing
 Roots: None identified
 Desiccation: None identified
 Dry/Groundwater: Wet at 2.62m
 Gas valve and cover installed

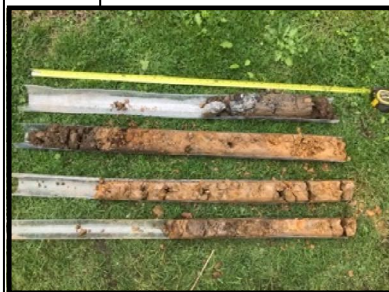
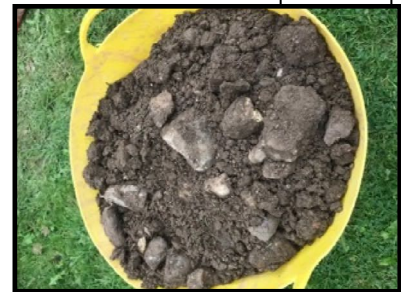
5.0m	Bag	N = 27			5.45	CLAY: Probable firm to stiff, brownish grey mottled orange, silty clay with occasional siltstone/mudstone lithorelicts	MRSL	
6.0m		N = 57				Borehole terminated at 5.45m depth; CPT testing continued to 6.42m depth

Casing used: No
 Trees: Refer to site drawing
 Roots: c0.4
 Desiccation: None identified
 Dry/Groundwater: Dry
 Gas valve and cover installed

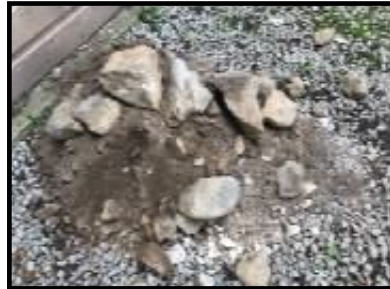
0.7	MADE GROUND: Probable loose to medium dense, mid brown, variably gravelly, slightly silty, 'soily' sand with fine rootlets up to c0.7m. Gravel is subangular, fine to coarse igneous rock with many cobbles at/below 0.5m depth ... impenetrable by hand digging and drilling below 0.7m depth; dynamic probe carried out instead		
1.0m								
2.0m						Borehole terminated at 0.7m depth; dynamic probe carried out		
3.0m								
4.0m								
5.0m

Casing used: No
 Trees: Refer to site drawing
 Roots: 0.6
 Desiccation: None identified
 Dry/Groundwater: Dry
 Gas valve and cover installed

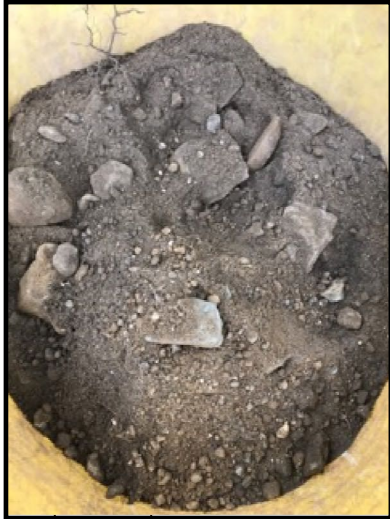
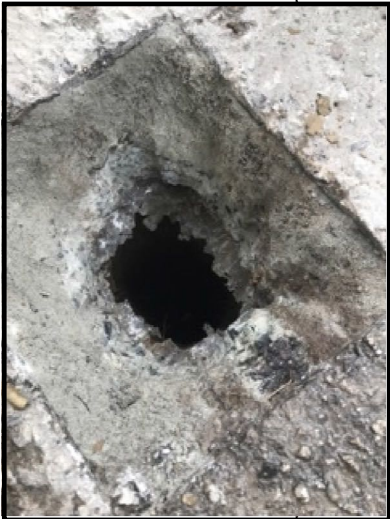
1.8	MADE GROUND: Loose, mid brown/greyish brown, slightly silty, gravelly 'soily' fine sand with fine roots/rootlets. Gravel is subangular, fine to coarse igneous rock with occasional to rare charcoal ... becoming very gravelly and locally orangish brown at 1.5m depth		
2.0m								
3.0m								
4.0m								
5.0m								
						<p>Borehole terminated at 1.8 depth upon impenetrable cobble; made ground collapsed back to 1.5m upon completion; infiltration testing carried out</p>		
						<div style="display: flex; justify-content: space-around;">

Casing used: No
 Trees: Refer to site drawing
 Roots: c1.1m
 Desiccation: None identified
 Dry/Groundwater: Dry
 Gas valve and cover installed

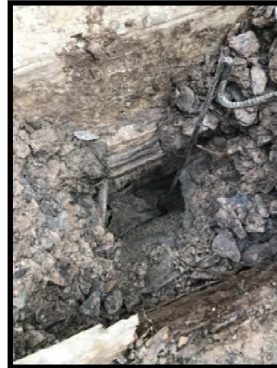
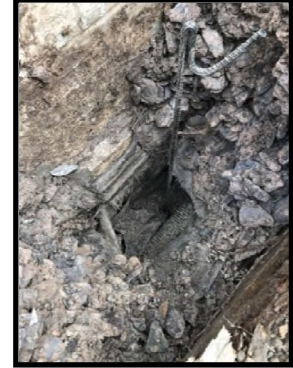
Site Photographs

It was suspected that the underside of the foundation was at around 1.3m depth. However this was not definitively proven - unknown if the suspected underside was instead the foundation being scratched away by the bar
 - unable to extend the pit deeper due to loose spalling material and lateral restriction by the ducting & pedestrian access

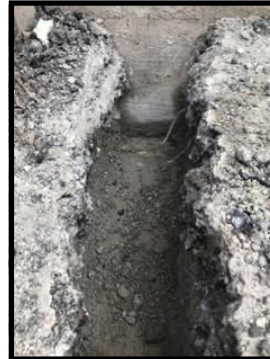
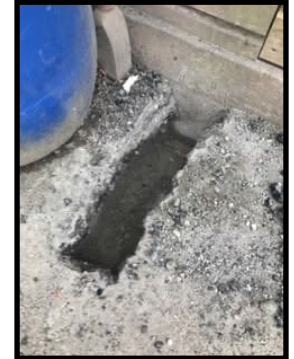
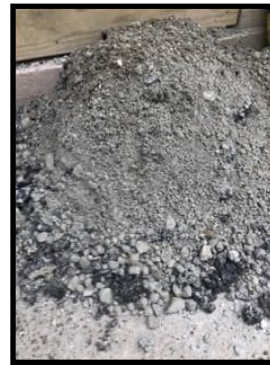
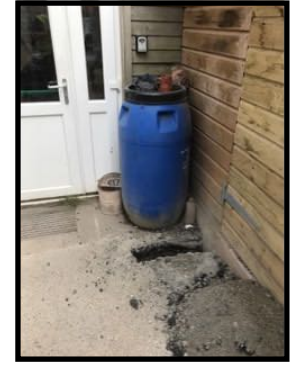
Site Photographs

A	MADE GROUND	Tarmac hardstand
B	MADE GROUND	Probable medium dense to dense, grey, compact, sandy gravel sub-base
C	MADE GROUND	Impenetrable concrete hardstand at 0.33m depth - extends >0.75m from the shed wall; unable to extend any further due to pedestrian access requirements

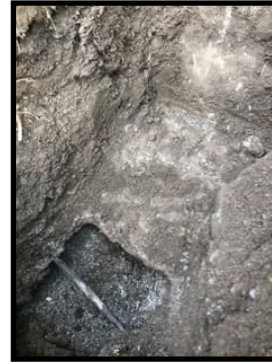
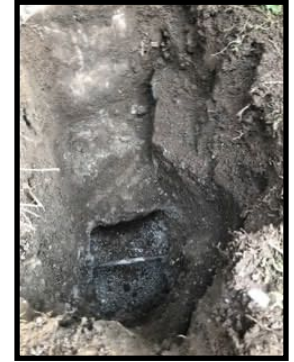
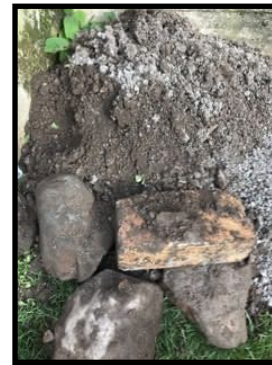
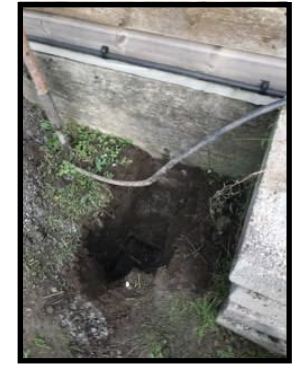
Site Photographs

A	MADE GROUND	Grass over mid brown, silty, rooted topsoil with fine rootlets
B	MADE GROUND	Probable loose, mid brown, slightly silty, gravelly, 'soily' sand with occasional fine rootlets up to 0.22m. Gravel is subangular, fine to coarse igneous rock including cobbles, with rare brick cobble and rare pottery/porcelain and charcoal
C	MADE GROUND	Loose, pale grey pea gravel of subangular, fine granite
